HASE I - FLIGHT TEST RESULTS

VOLUME II

ADVANCED ENGINE & TECHNOLOGY DEPARTMENT
GENERAL ELECTRIC COMPANY
CINCINNATI, OHIO 45215

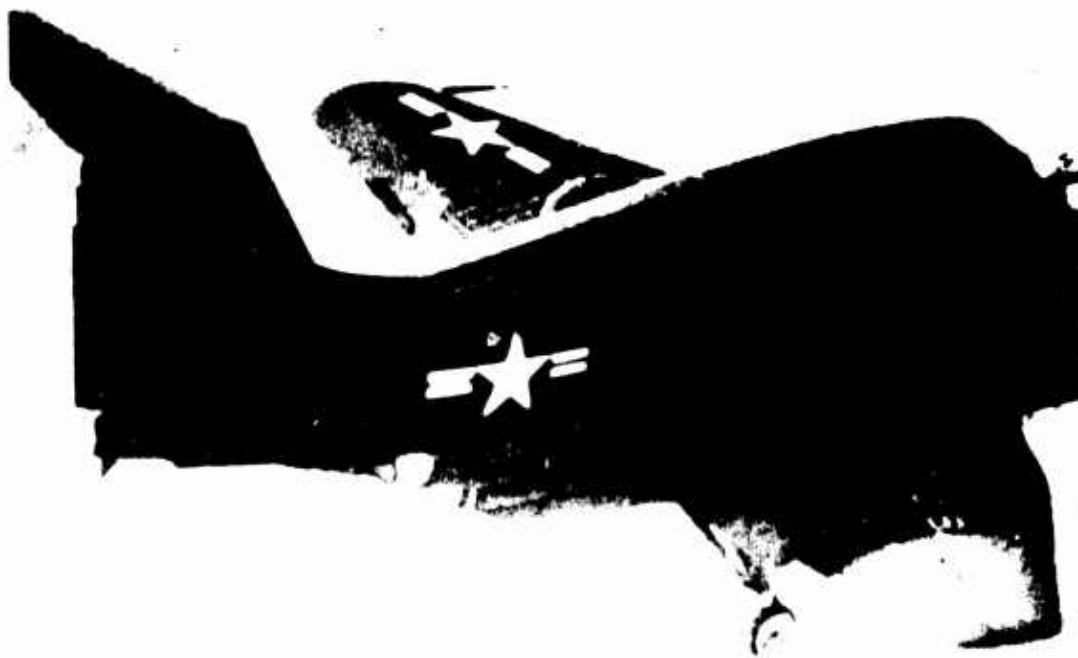
Figure 7.9 Photograph of Tufted XV-5A

As a result, the fuselage, wing, horizontal stabilizer and elevator were tufted for airflow visualization moving pictures in flight (Figures 7.9 and 7.10). The problem appeared to be a result of flow separation at the intersection of the horizontal stabilizer and vertical tail maximum thickness points, as indicated by the chase plane.

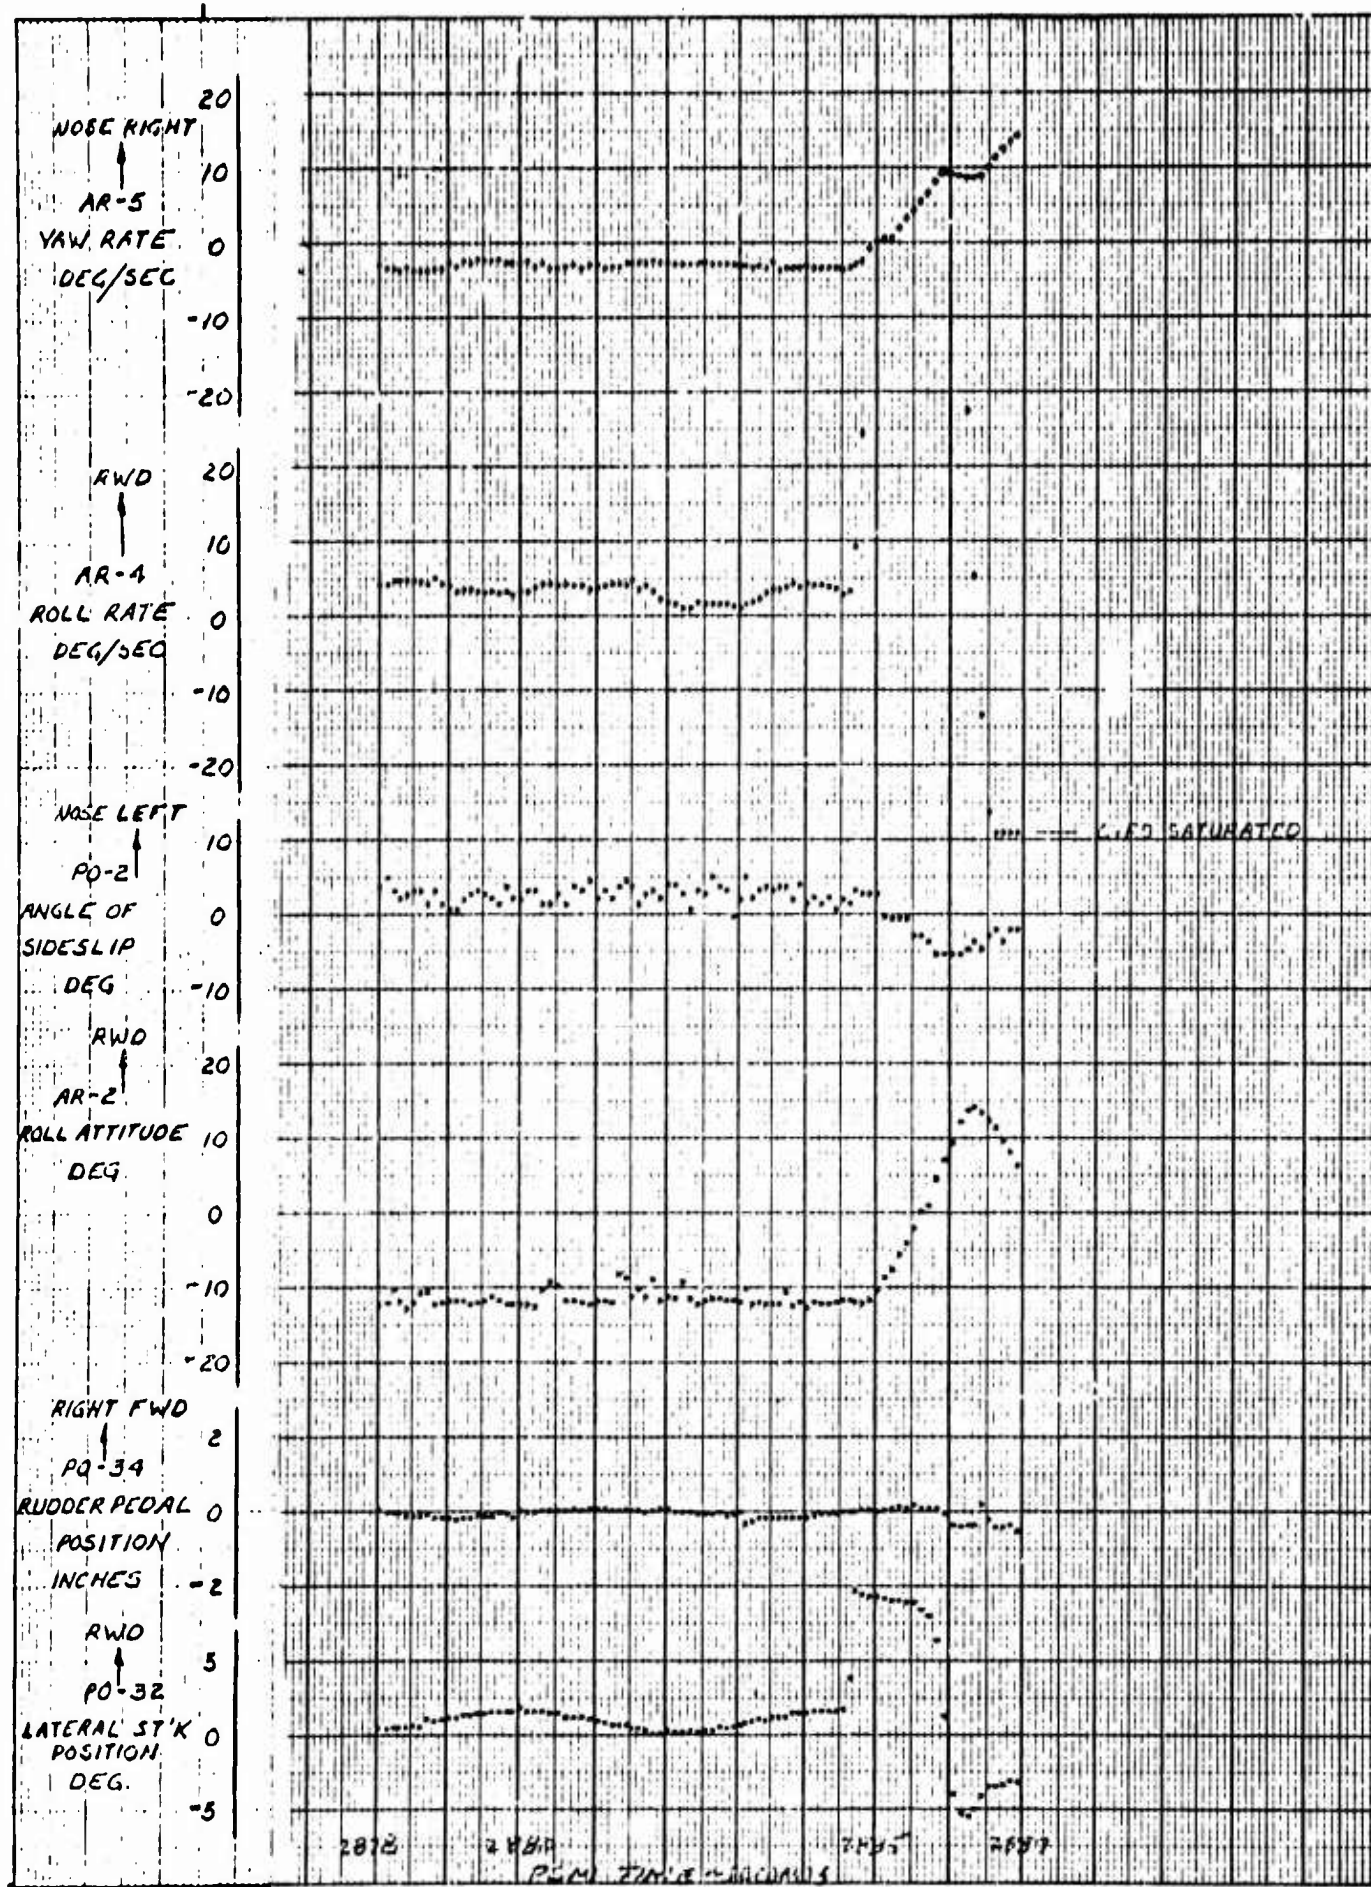
Figure 7.30 Time History of Roll Manuevers - Configuration PA

Roll maneuvers at 130 KIAS in Configuration "PA" are presented in Figures 7.28 through 7.35 for both a locked and coordinated rudder. These data indicate a favorable yaw angle of 10° for rudder locked with
